Evaluation of Full Scale Levee Stability Tests at Booneschans and Corresponding Centrifuge Tests

M. A. Van

Expertise Manager, Deltares, P.O. Box 177, 2600 MH Delft, The Netherlands, meindert.van@deltares.nl

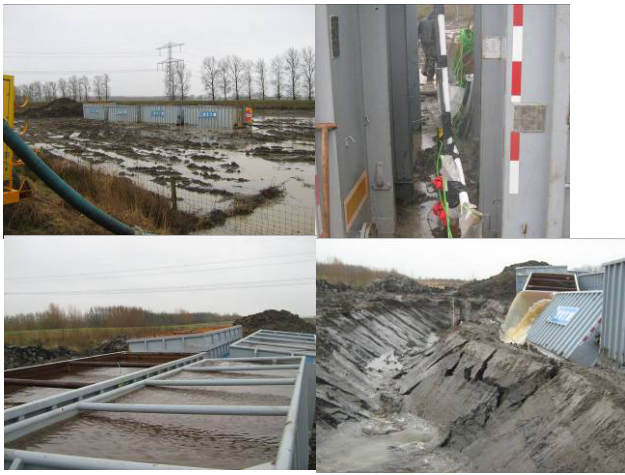
Figure 4. a) Overview preliminary test b) Measurement row at the centre of the container row c) Filling of the containers d) Failure

After failure, the containers were removed and the failure plane was examined by excavating an observation pit. The active part of the sliding plane was found to be very steep, followed by a horizontal part through the peat layer, leading to the ditch bottom. It should be noted that for the location of the preliminary test a 2.5 m thick organic clay layer was present on top of the peat layer.

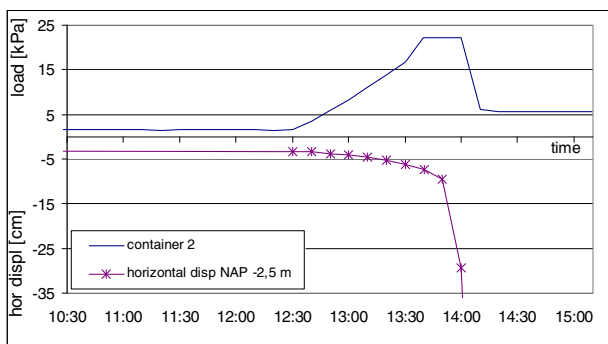
Figure 5. Horizontal deformation of the subsoil at ground level -1.5 m during filling of the containers

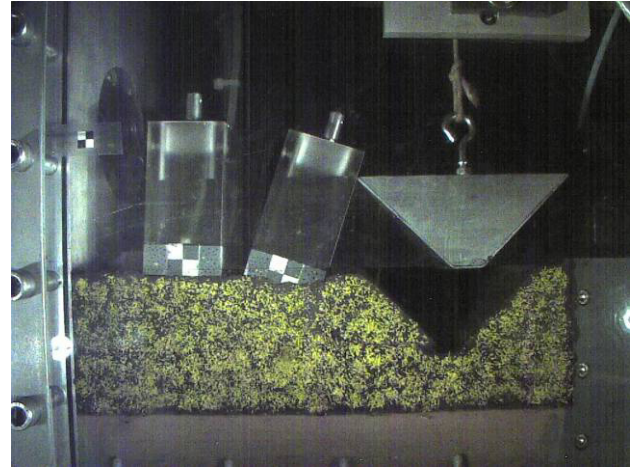
Figure 6. Centrifuge test representing the preliminary test

Figure 6 shows the failure plane observed in the centrifuge tests. Horizontal sliding dominates the failure mechanism. Figure 7 shows the horizontal deformation found in the centrifuge test at three different levels below ground level at the front of the containers. The horizontal displacements are found after creation of vector plots from images like the one shown by Figure 6. The vector plots and the displacement graphs are made using particle image velocimetry (PIV) for use in geotechnical testing(White, 2003). The PIV-analyses was carried out with the PIV software tool developed by White (2002). In comparing centrifuge and the full scale tests, a depth of -18mm in the centrifuge test corresponds to -0.9 m in the full scale test, likewise -28 mm corresponds to -1.4 m and -38 mm to -1.9 m. In the centrifuge test the slip plane lays between -28mm and -38mm. Figure 7 shows that directly when the filling of the containers start, $t=0$, a continuous horizontal deformation starts.

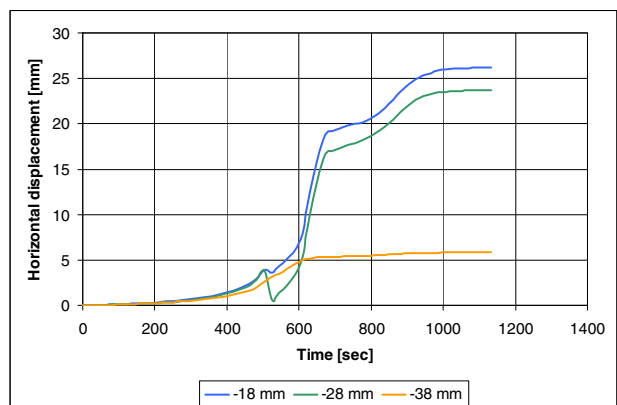
Figure 7. Horizontal deformation at 3 different ground levels in centrifuge test

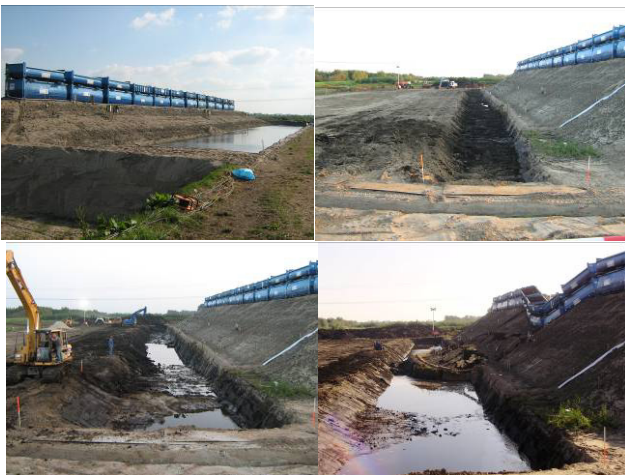
The construction phase of the test embankment started on August 13th 2008 and was finished on September 19th 2008. The test started on September 25th by filling the bathtub in front of the dike, see Figure 8a. Later that day the top clay layer was excavated, see Figure 8b, at the toe of the dike. On September 26th the ditch was fully excavated, on to the top of the sand layer, see Figure 8c. On September 27th the sand core was filled with water. The filling started at 12:07h, at 16:00h deformation could be observed visually, failure was found at 16:02h, see Figure 8d.

Failure was reached during filling of the sand core; the containers on top of the dike were not filled. The observed failure plane had a width of 40 m. Equivalent to the preliminary test, horizontal deformation dominated the occurred sliding. After failure was reached an observation pit was excavated to examine the sliding plane. The active part of the sliding plane could not be recovered. Probably the active part is present under the centre of the embankment that could not be reached by the excavation. A long horizontal failure plane was found on the transition of the peat layer and the sand layer.

Figure 8. a) River side of the dike, b) Inner side of the dike during excavation of the ditch, c) Inner side of the dike after excavation of the ditch, d) Failure

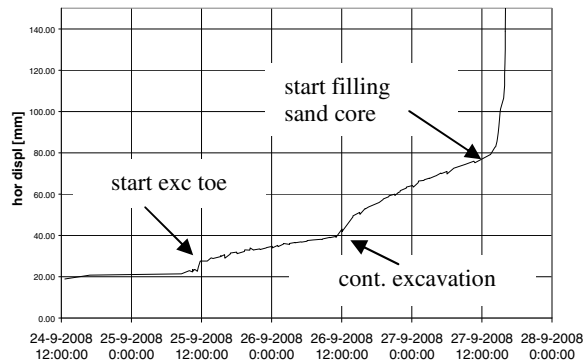
Figure 9 shows an impression of the measurements. The horizontal deformation was measured at 1/3 of the inner slope. The initial horizontal deformation, approximately 20 mm, was found during the construction of the dike. Figure 9 shows that, although not visually observed, the horizontal deformations started to develop as soon as the excavation at the toe started. On the morning of September 26th the deformations seemed to slow down until further excavation started around noon. Then, the horizontal deformation accelerated. The next day, the horizontal deformation further accelerated when filling of the sand core with water started at noon, until failure occurred at 16:02h. The measurements show that continuous and consequent horizontal deformation occurs in the subsoil long before it can be observed visually at the surface.

Figure 9. Horizontal displacement at 2 m below ground level
