LESSONS LEARNED FROM A FULL-SCALE DYKE FAILURE TEST

André R. Koelewijn
GeoDelft
Delft, Netherlands

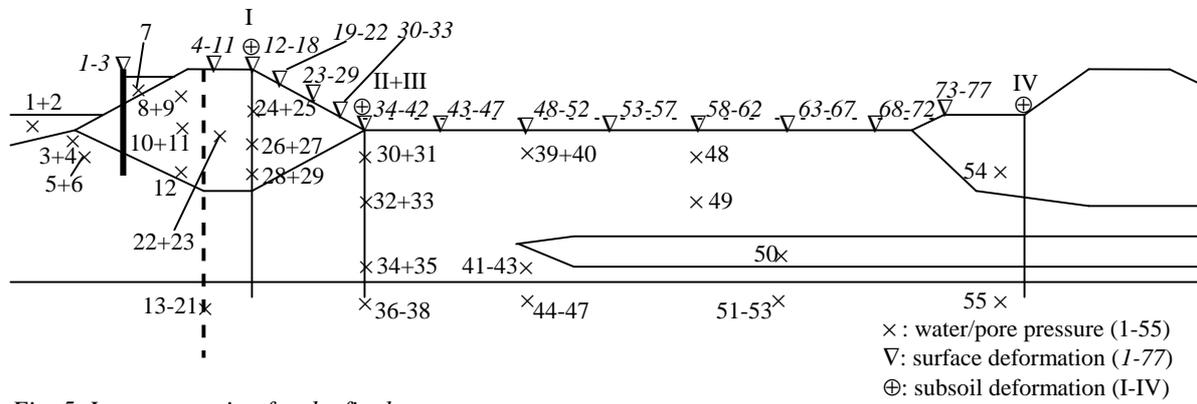
Fig. 5. Instrumentation for the final test.

The instrumentation finally used is shown in Fig. 5. It consists of 55 water and pore pressure meters, each with a sampling frequency of once every two minutes, four inclinometers and one extensometer (at location I in the figure) with the same sampling frequency, one total station to measure surface deformations and covering 57 points distributed over the

The first stage of the test started on the 17th of September. During the first high tide about 80% of the capacity of the infiltration wells was used and the old dyke came at the brink of failure: at surface deformation meter 55 (Fig. 5) an upward displacement of 140 millimetres was recorded, while inclinometer II showed a displacement towards the new dyke of about 20 millimetres near the bottom of the soft layers and

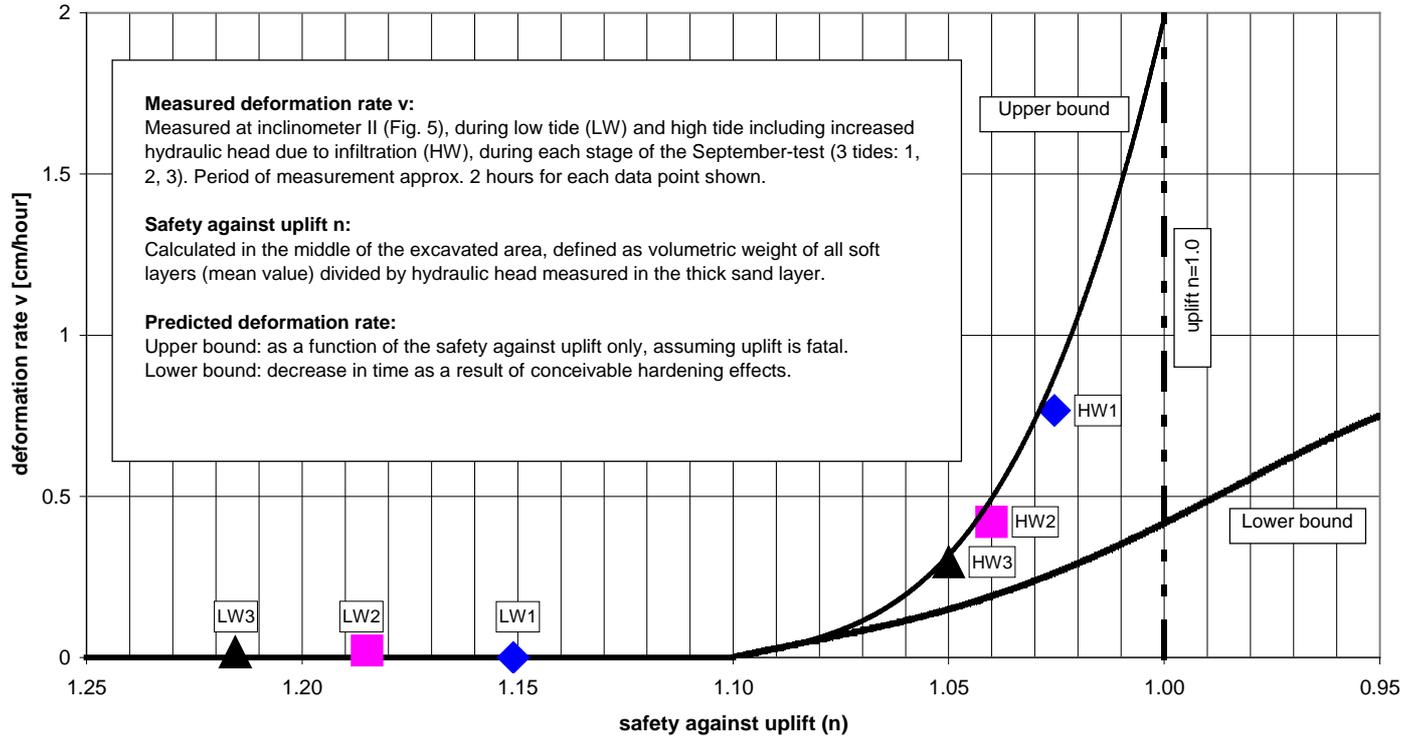
Fig. 6. Deformation rate against uplift safety, as measured in September.

In Fig. 6 the deformation rate below the toe of the old dyke during the various stages of this test is shown against the safety against uplift in the centre of the excavated area, indicating that the deformation rate strongly depends on the safety against uplift.

During the first two days of the test, with an achieved safety against uplift between 1.01 and 1.10, the deformations were comparable to those in September, cf. Fig. 6. In this period already three infiltration wells failed, probably as a result of the deformations which had already started.

Because of the rather sudden collapse of the tested dyke, the hope that an early warning system can be based on monitoring the deformations of dykes has proved to be idle. A more positive outcome of this test is the observation that uplift does not necessarily lead to failure: the dyke only collapsed when the safety against uplift as defined in Fig. 6 was significantly below 1.0.

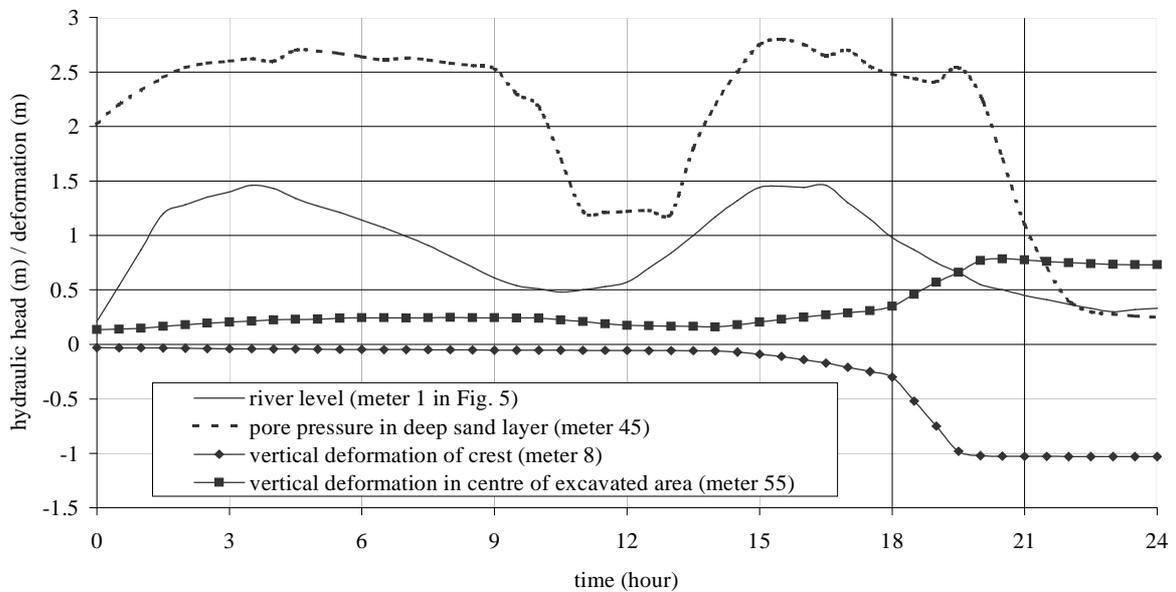
Fig. 7. Main measurements during day of dyke collapse.

In the afternoon of the third day, around half past three the maximum hydraulic head underneath the old dyke and the excavated area was reached, with a calculated safety against uplift of about 0.95. At this point the deformation rate increased strongly with a further increase after another few hours when the pore pressures were somewhat lower again. As shown in Fig. 7, deformations of the old dyke of over one metre occurred. The extent of the failure was much larger than expected: 110 metres instead of 50 metres only. As a result the image processing system failed, as the cameras stood within the area of the slide. Figure 8 shows the collapsed dyke. To the left in this picture the risen part of the excavated area is clearly visible.
